# FOLLOW-UP STUDY ON ROAD SAFETY AND ACCESSIBILITY OF İSTANBUL METROBÜS

JULY 2014  
Working Paper

# EMBARQ

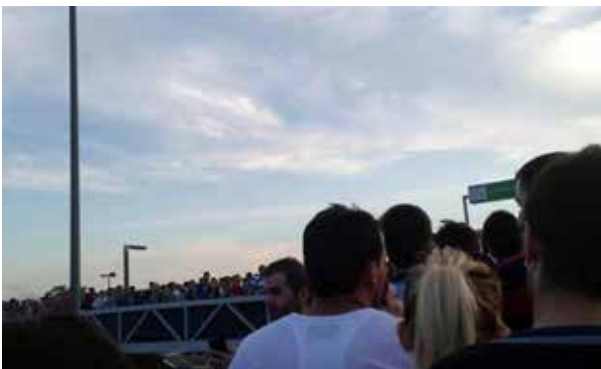
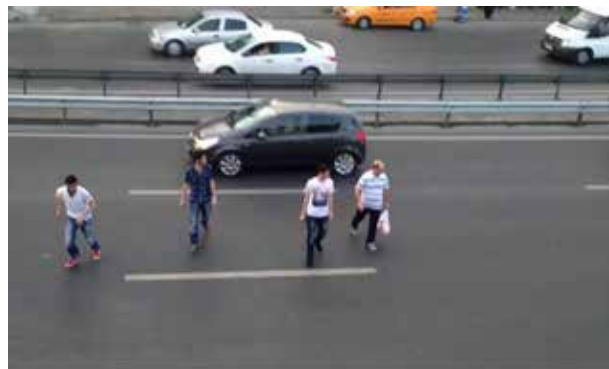
**Figure 10** Oversaturated flow results in some passengers wait or walk on the Metrobüs corridor rather than on the passenger platform<sup>11</sup>

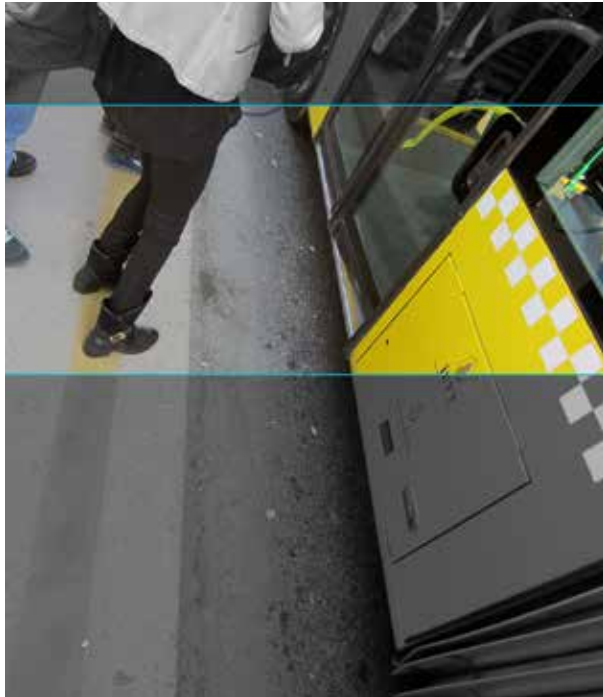
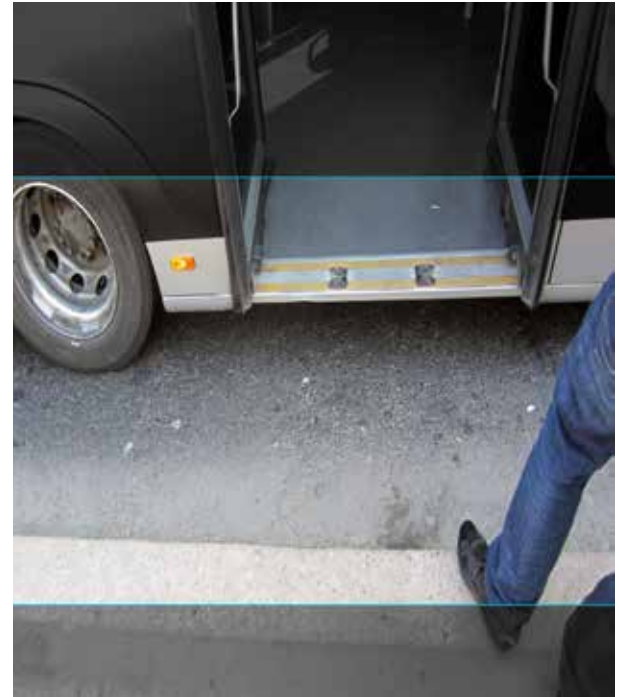
It has been observed that Metrobüs drivers fail to stop close to the passenger platform in stations where no bollards are in place. The gap between the station platform and Metrobüs busses is a challenge for physically disadvantaged people during their boarding and alighting. To solve this problem, station-specific configurations have been

**Figure 14** The gap between the bus and the passenger platform

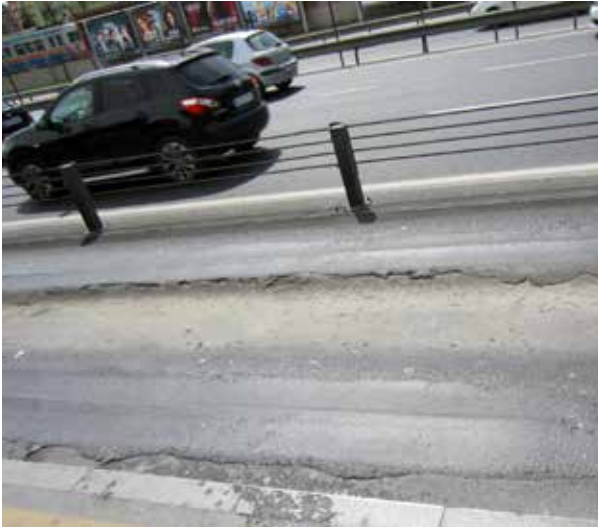
Despite the maintenance we still observe surface deterioration (e.g. rutting and etc.) in some stations due to such reasons as the heavy weight

of the busses, their stop-and-go movements, and weather conditions.

**Figure 18** Examples of rutting and similar surface deterioration

We have observed surface deteriorations, which are related to tensions and deformations on the road pavement particularly along the stations and when approaching and leaving the stations. Rutting is the most common surface deterioration that we observed. Rutting is the longitudinal surface depression that develops in the wheel paths of asphalt concrete. This depression may develop at any layer of the road from subgrade to pavement. It generally develops due to high and heavy traffic and climatic conditions. The water puddles that occur on the asphalt surface due to rutting jeopardize the road safety directly, leading to shocks, loss-of-control, skidding, and shorter stopping distance. Especially in winter when water in the ruts is frozen, drivers may lose control and cause major accidents. To minimize the rutting on the road surface, the workmanship during laying of asphalt as well as the weather conditions during road works should be taken into account especially within the road repair and maintenance program.

To prevent such deterioration, we recommend that polymer derivatives be added to the asphalt mixture in specific stations depending on the weather conditions of İstanbul. Another recommended solution is to replace these sections of the road with concrete pavement.

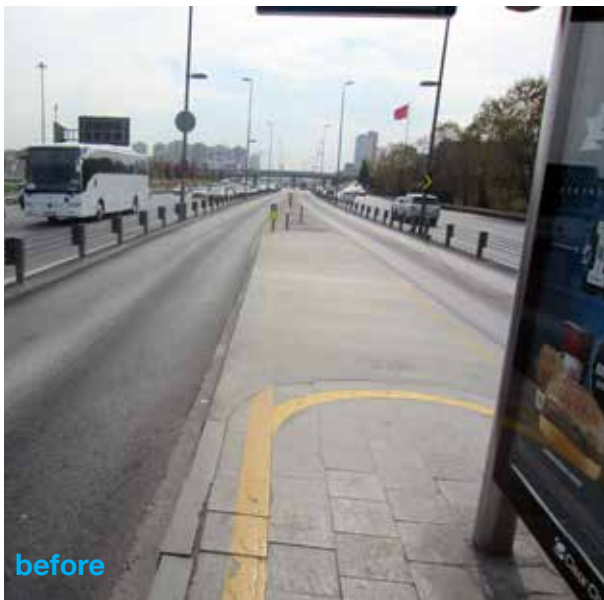
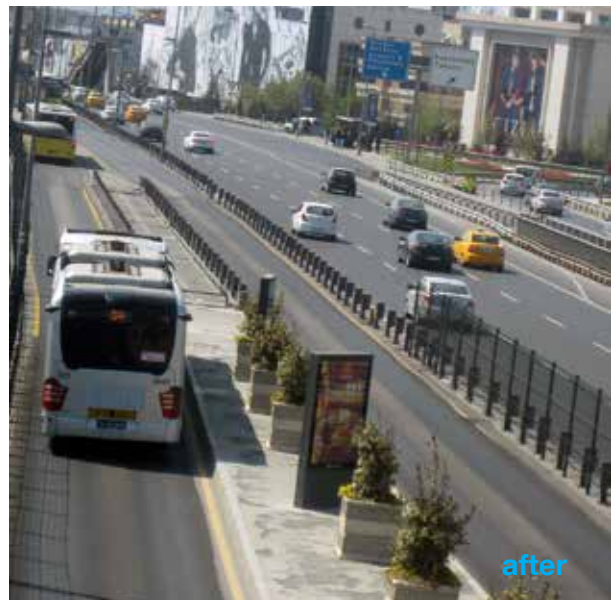
It is proposed in the traffic safety report that the end borders of the station platforms are blocked and fences be stretched over to the end of the ghost islands to stop passengers from entering to station platforms by violating traffic rules and signs and prevent them from walking on the Metrobüs way. Officials placed billboards and concrete planters on the platform ends to at least show people that it is not a waiting area. However, it

**Figure 21** An example of a station where platform ends are not blocked for access and fences are not stretched long enough to the end of the ghost islands

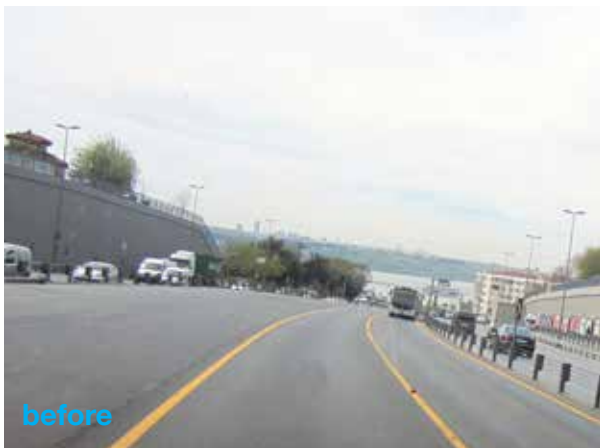
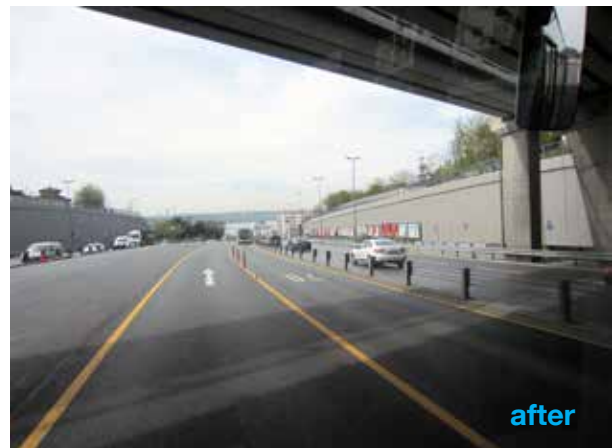
Only one section of the Metrobüs corridor does not have any median refuge. Having no median refuge increases the risk of head-on collisions. Therefore, this section of the corridor has been

**Figure 23** Example of a Metrobüs section where there is no median refuge (the section between Florya and Cennet Mahallesi)

equipped with cat eyes and markings. Since this is not adequate by itself a median refuge is recommended to reduce the risk of accident.

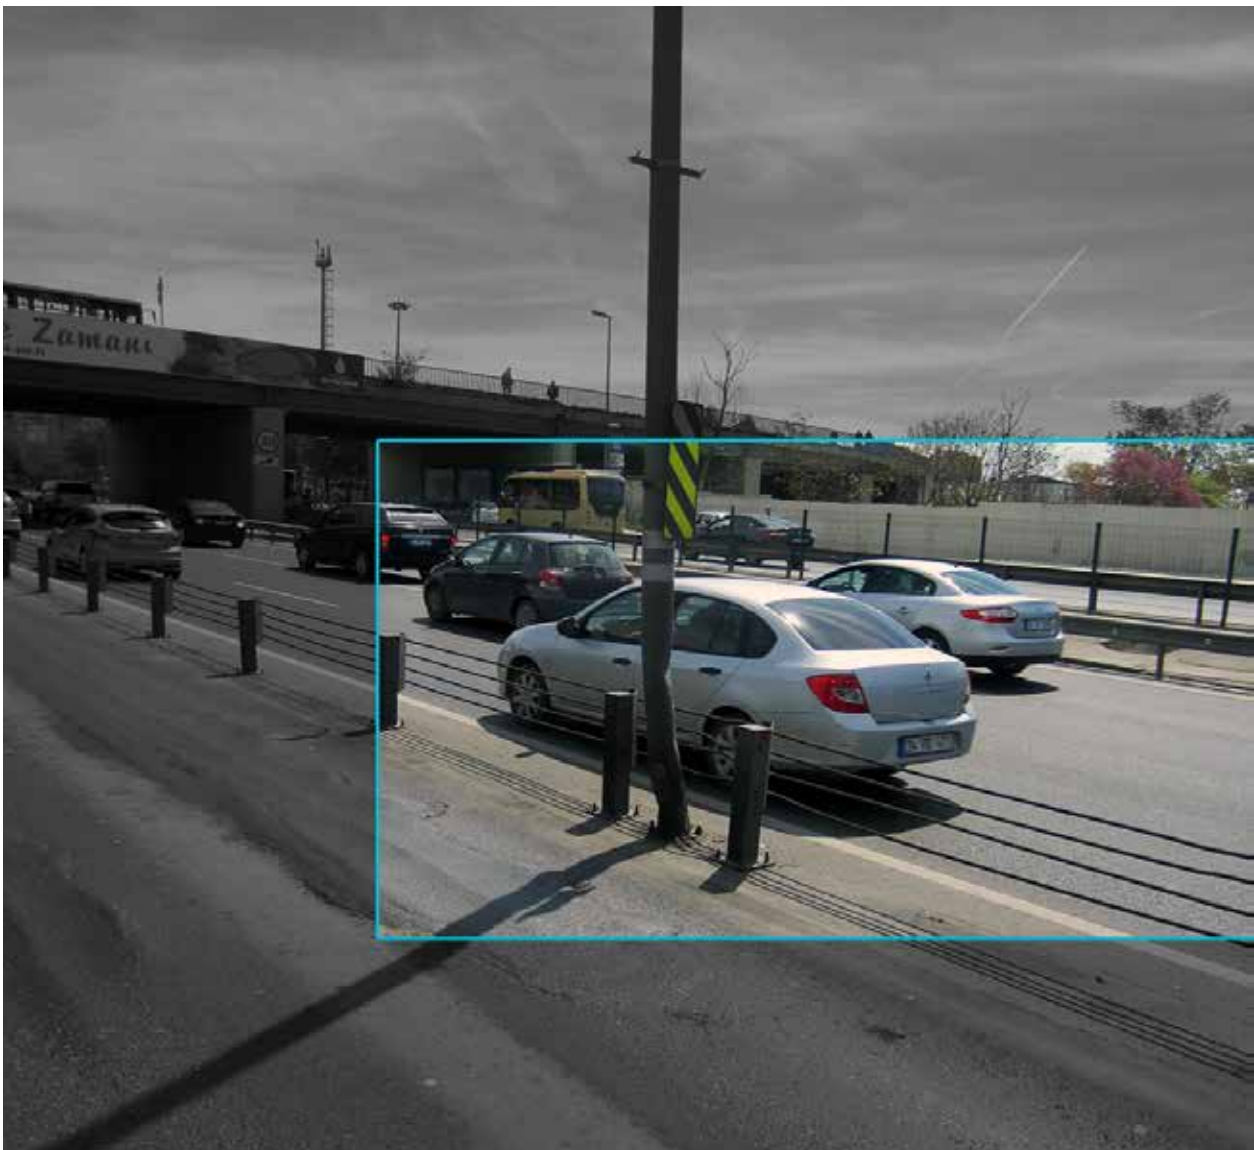
Another deficiency, for which an improvement is proposed in the “Road Safety Inspection of Metrobüs BRT” Report, is that the poles lack configuration and protection against accidents. For this, officials marked the poles with yellow (for guiding) to make them more noticeable. It is also very essential to protect the poles against collision.

**Figure 24** Example of a pole not protected against collision

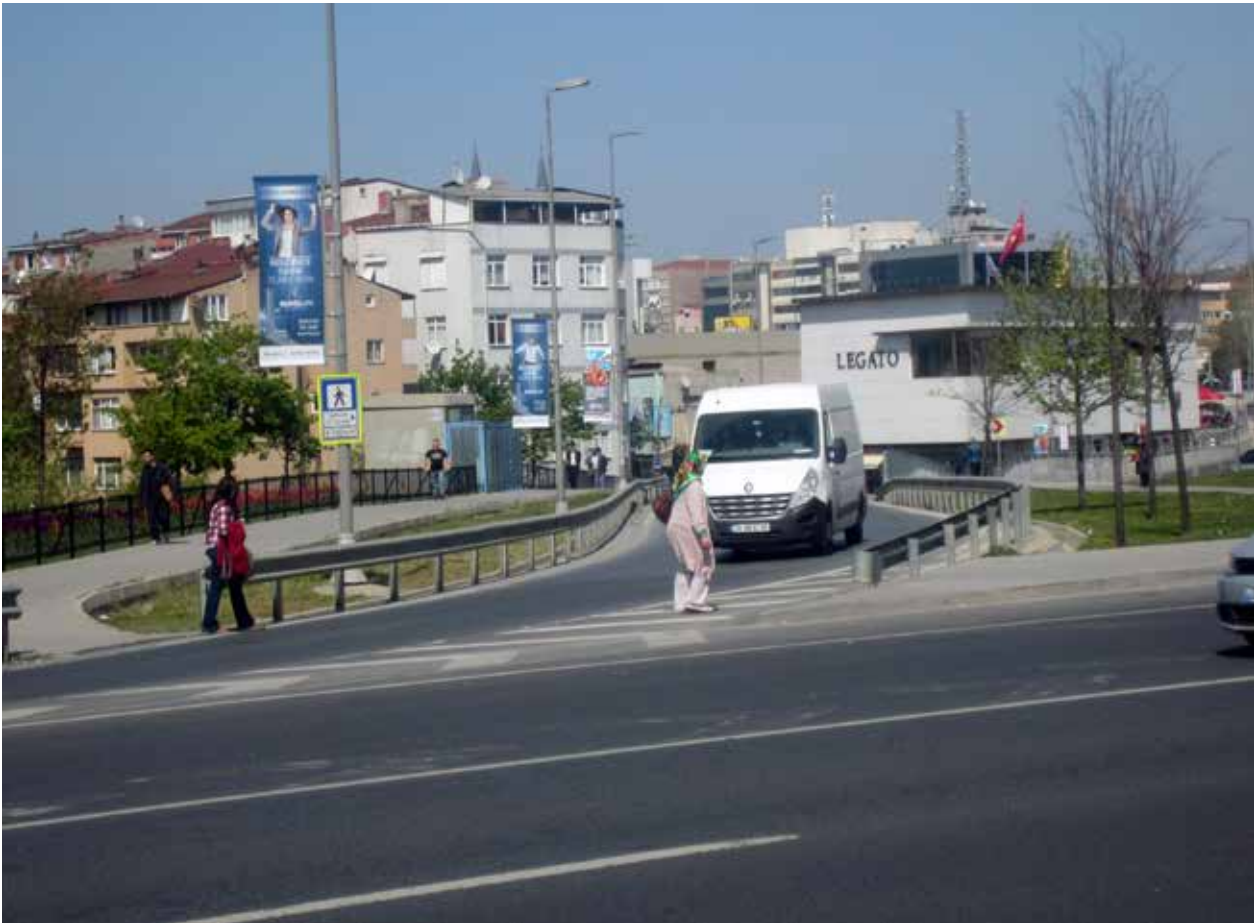
also a major problem from the road safety aspect: “buses hitting pedestrians when they are crossing the road” is the most common of the three main causes of accidents that occur on İstanbul Metrobüs corridor.

**Figure 25** Buses hitting passengers when they are crossing the road (lack of safe access)

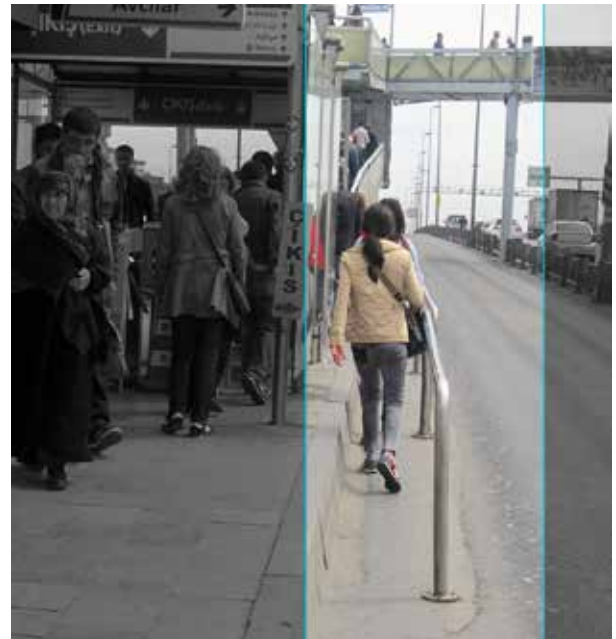
**Figure 28** Example of a station where guardrail for passengers is on the road

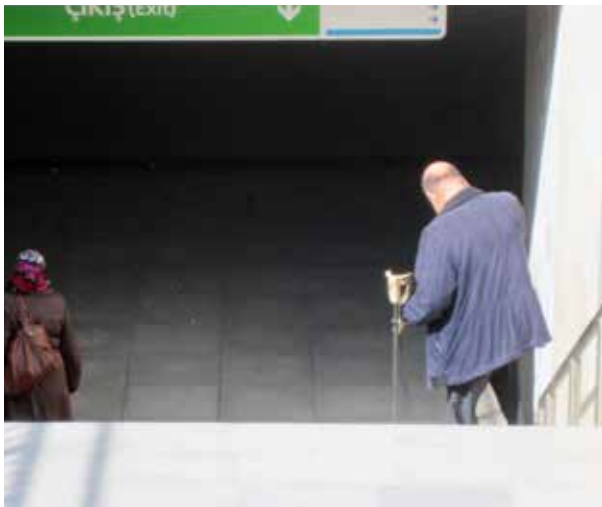
Another challenge for integration is the lack of pavements around Metrobüs stations or pavements in poor condition. Similarly, curbside parking and fixed objects blocking the pavements are among the major problems of accessibility

**Figure 32** Example of a station with poor accessibility for disabled people, elderly people, and people with pushchair

Moreover, ramps and elevators should be in place for people with special conditions (e.g. disabled people, elderly people, people with pushchairs, etc.) to improve their access to stations, especially in locations where people access to stations using underpasses and overpasses. This is what the officials primarily address when improving access to Metrobüs stations.

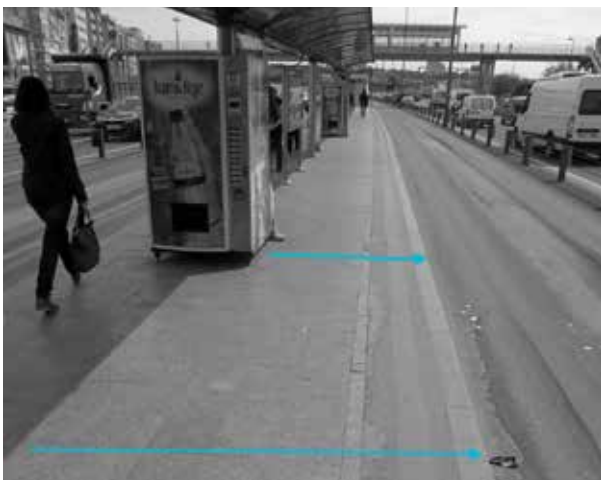
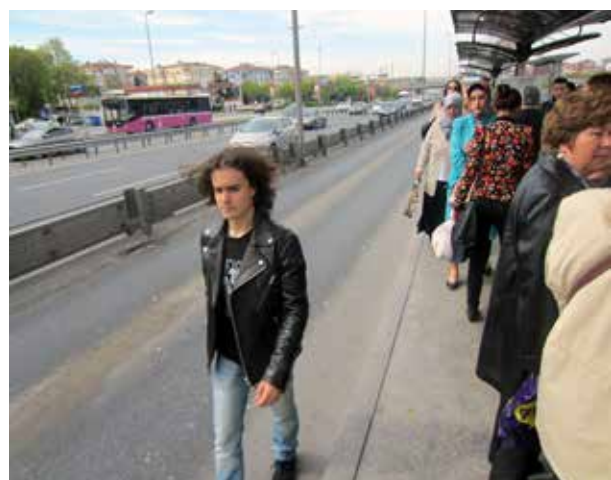
Water dispensers that have been placed recently on station platforms also affect the passenger flow adversely in peak hours. In platforms, which are not wide enough for passenger movement, the water dispensers decrease the cross-section capacity and the volume of passenger circulation. As a result passengers walk off the station

**Figure 36** Example of a station where water dispensers decrease cross-section capacity and affect the volume of passenger circulation
