# FOLLOW-UP STUDY ON ROAD SAFETY AND ACCESSIBILITY OF İSTANBUL METROBÜS

JULY 2014  
Working Paper

# EMBARQ

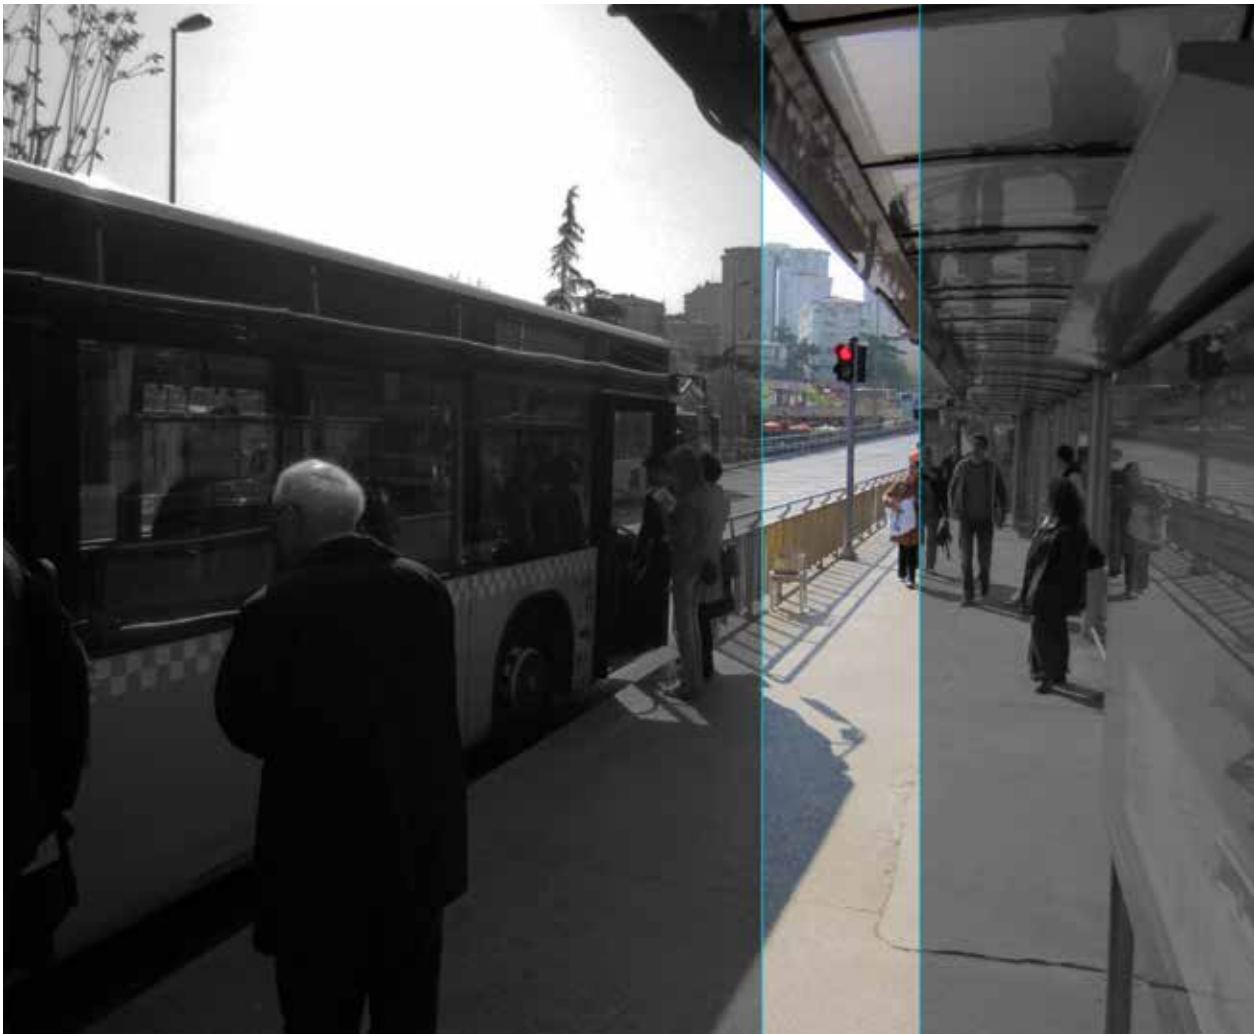
**Figure 12** A station where stop and go signals are erected in both directions

In 2014, stop and go signals have been placed in both directions. Before that, platform staff was available to manage it. Our on-site inspection has

revealed that this is still done by the platform staff at some stations.

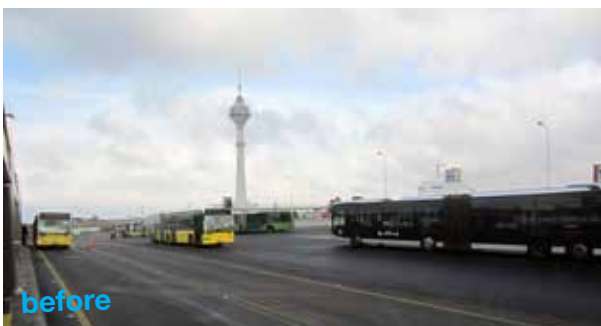
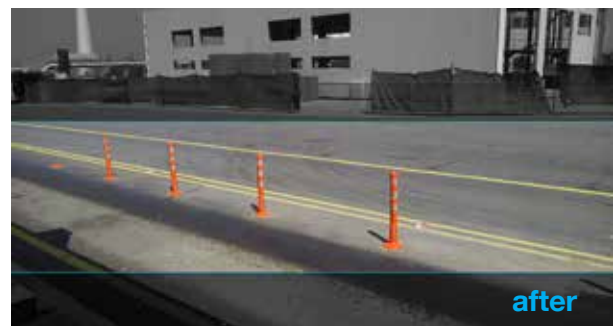
**Figure 13** Bollards are placed in some stations so that BRT busses can draw in the passenger platform

It has been observed that Metrobüs drivers fail to stop close to the passenger platform in stations where no bollards are in place. The gap between the station platform and Metrobüs busses is a challenge for physically disadvantaged people during their boarding and alighting. To solve this problem, station-specific configurations have been

introduced. For example Bollards were placed to narrow lanes so that drivers were guided to stop close to station. It is proposed that this solution be adopted in other stations, and that Metrobüs and other IETT drivers be trained in how to pull in alongside the station platforms.

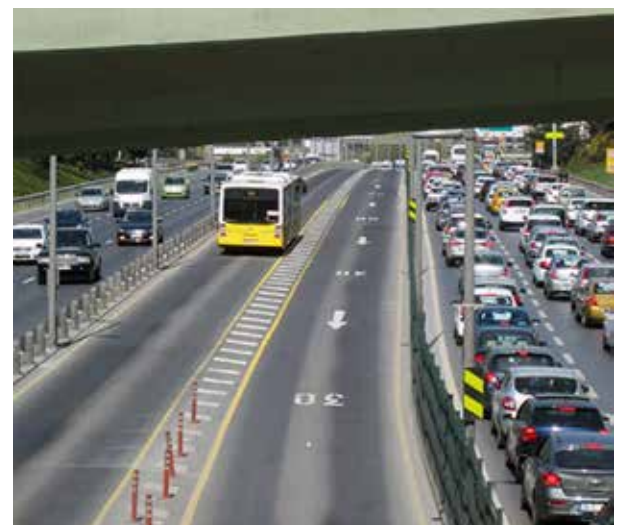
**Figure 15** Horizontal Markings Showing the Speed Limit

The risk of death or severe injury in traffic accidents increases considerably for pedestrians when vehicle speeds are higher. For example, when a vehicle hits a pedestrian at 40 km/h speed, the risk of fatality is 40%. This rate is 80% and near 100% when the speed of the vehicle is 50 km/h and 80 km/h, respectively<sup>12</sup>. In other words, buses are highly dangerous when they drive through stations with high speed. Therefore, the road surface is marked with the speed limit just before the stations. We have observed that these horizontal markings are not fully visible in some station because of repair and maintenance works on the road surface. It is important that the markings be renewed as soon as possible for the sake of traffic safety.

It has been observed during the site inspection that some bus drivers disobey the speed limit and drive through the stations with high speed. A Metrobüs driver who loses control due to

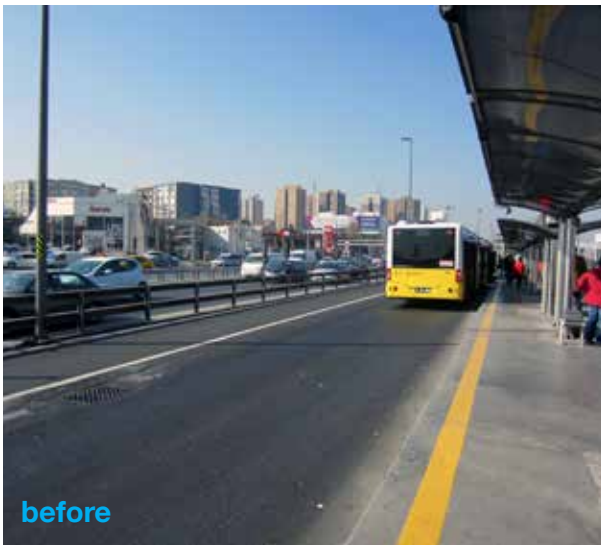
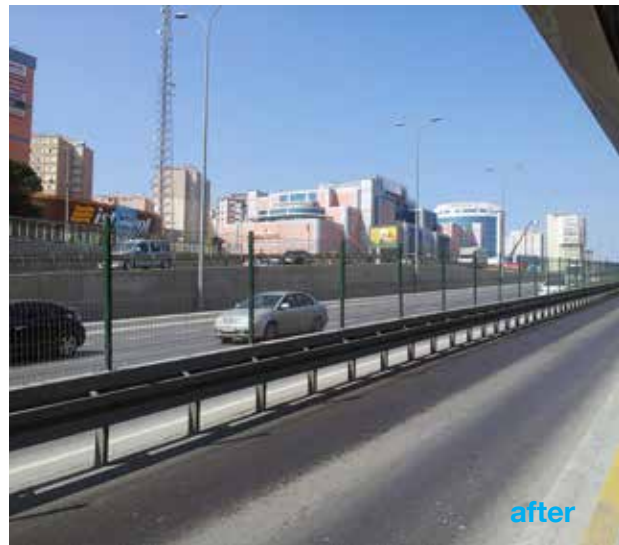
**Figure 16** Wire fences for pedestrians

platform by crossing the highway. Therefore, it is very important to install guardrails with fences along the stations to prevent such crossings. İETT officials have reported that they made some improvements on this issue. We strongly recommend that these guardrails be stretched over to the end of the central ghost islands at both sides of the station.

- Wire fences were installed in 17 stations. However, they failed to be adequate in Fikirtepe, Darülaceze and Cevizlibağ stations. Wire fences should be placed on both sides of the road, and extended till the end of the ghost islands.
- Horizontal road markings of speed limit and ghost islands are available in almost all stations. Such markings should be refreshed as soon as possible during the repair and maintenance of the asphalt pavement.
- The platform ends were connected to newly construct under/overpasses in 3 stations. It is proposed that the end borders of other stations be closed as well.
- Station platforms were enlarged in 7 stations to reduce crowding.
- Entrances and exits are separated in 19 stations. Moreover, boarding and alighting platforms are separated in 6 stations.
- Turnstiles were relocated to the overpasses at 9 stations.

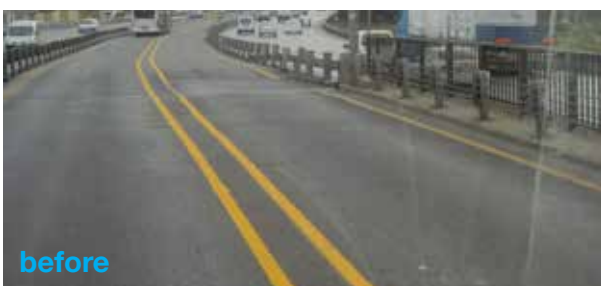
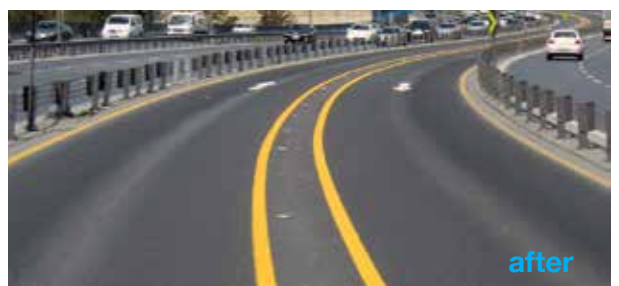
**Figure 17** Metrobüs road surface repair-maintenance works

We have observed that the road surface was repaired and maintained along the Metrobüs corridor, while in some areas the repair-maintenance works are still ongoing. In some sections of the route, ghost islands on the road surface have faded due to asphaltting. Metrobüs officials have reported that they will remark the ghost islands step by step all along the route. They also reported that they would mark ghost islands on the road surface in Cennet Mahallesi station.

Despite the maintenance we still observe surface deterioration (e.g. rutting and etc.) in some stations due to such reasons as the heavy weight

of the busses, their stop-and-go movements, and weather conditions.

To prevent such deterioration, we recommend that polymer derivatives be added to the asphalt mixture in specific stations depending on the weather conditions of İstanbul. Another recommended solution is to replace these sections of the road with concrete pavement.

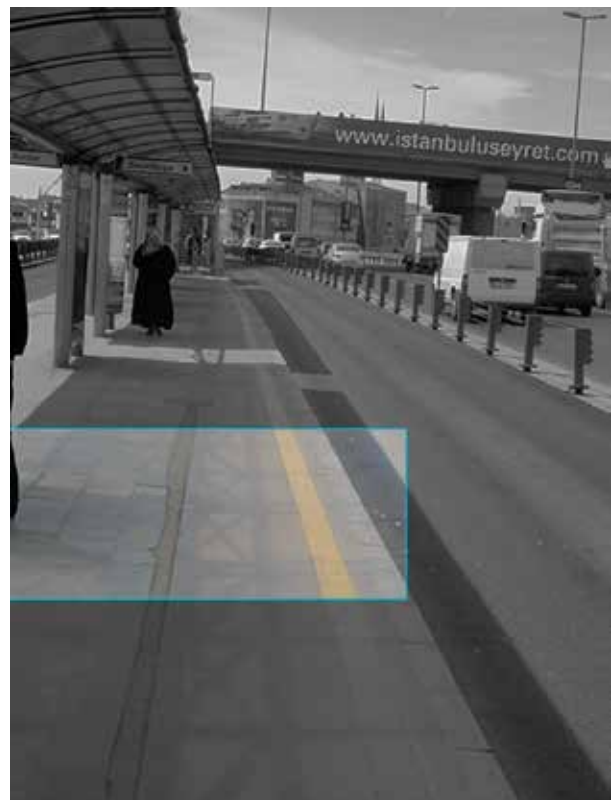
**Figure 19** Example of an enlarged station platform

We have observed in the on-site inspection that station platforms were extended and enlarged depending on travel demand.

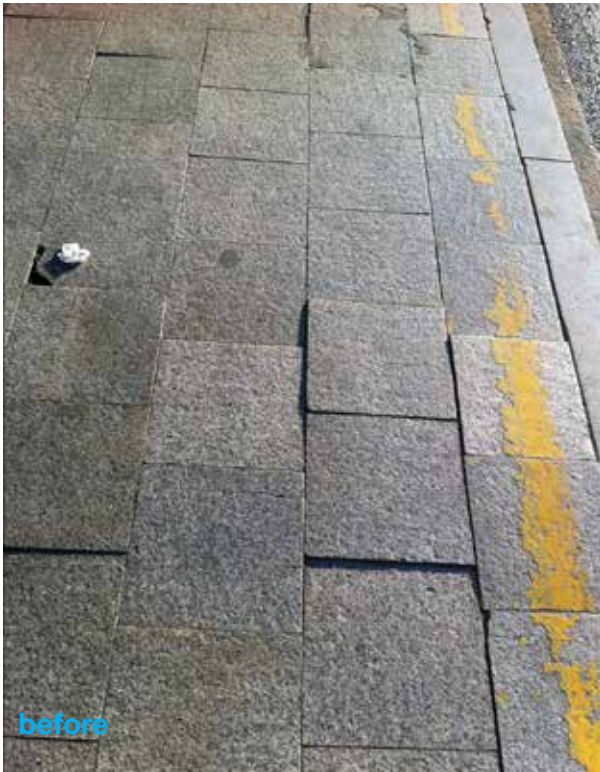
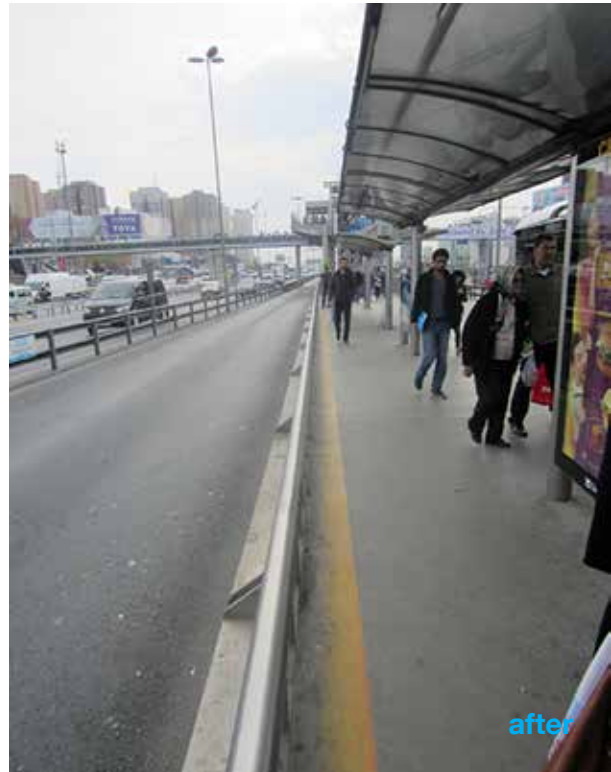
**Figure 20** Example of a yellow line marking and surface smoothing

In the majority of the stations, floors of the platforms were replaced and marked with yellow lines at the edge when enlarging the station. Moreover, platform surface was smoothed during the enlargement work. It is essential to lay tactile tiles on station platforms for visually impaired people. İETT currently plans to turn the yellow lines on the station platforms into tactile tiles.

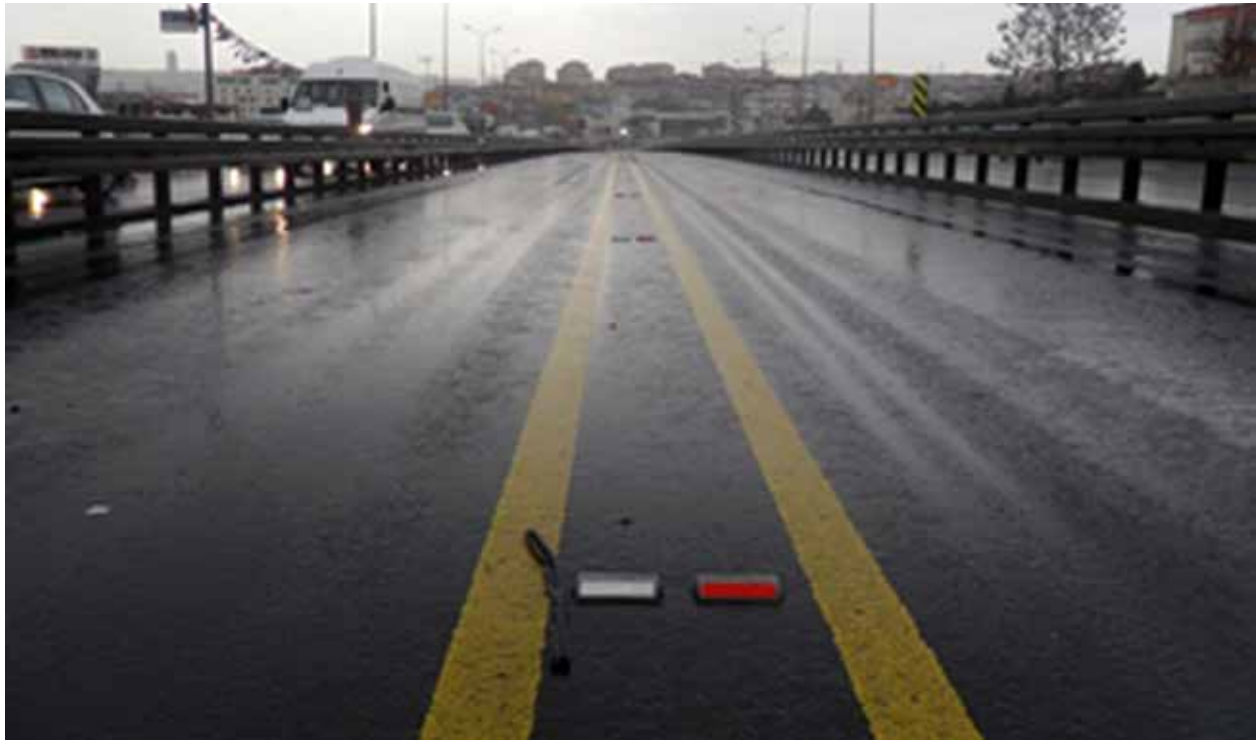
**Figure 22** Example of cat’s eyes lay down along the median refuge

Another risk is that there is no median refuge available between the two opposite lanes. This increases the risk of head-on collision. “Road Safety Inspection of Metrobüs BRT” report recommended that the opposite lanes be

separated not only with yellow line but also with cat’s eyes to capture the attention of the drivers. Therefore cat’s eyes were laid down along the median refuge.

Only one section of the Metrobüs corridor does not have any median refuge. Having no median refuge increases the risk of head-on collisions. Therefore, this section of the corridor has been

equipped with cat eyes and markings. Since this is not adequate by itself a median refuge is recommended to reduce the risk of accident.

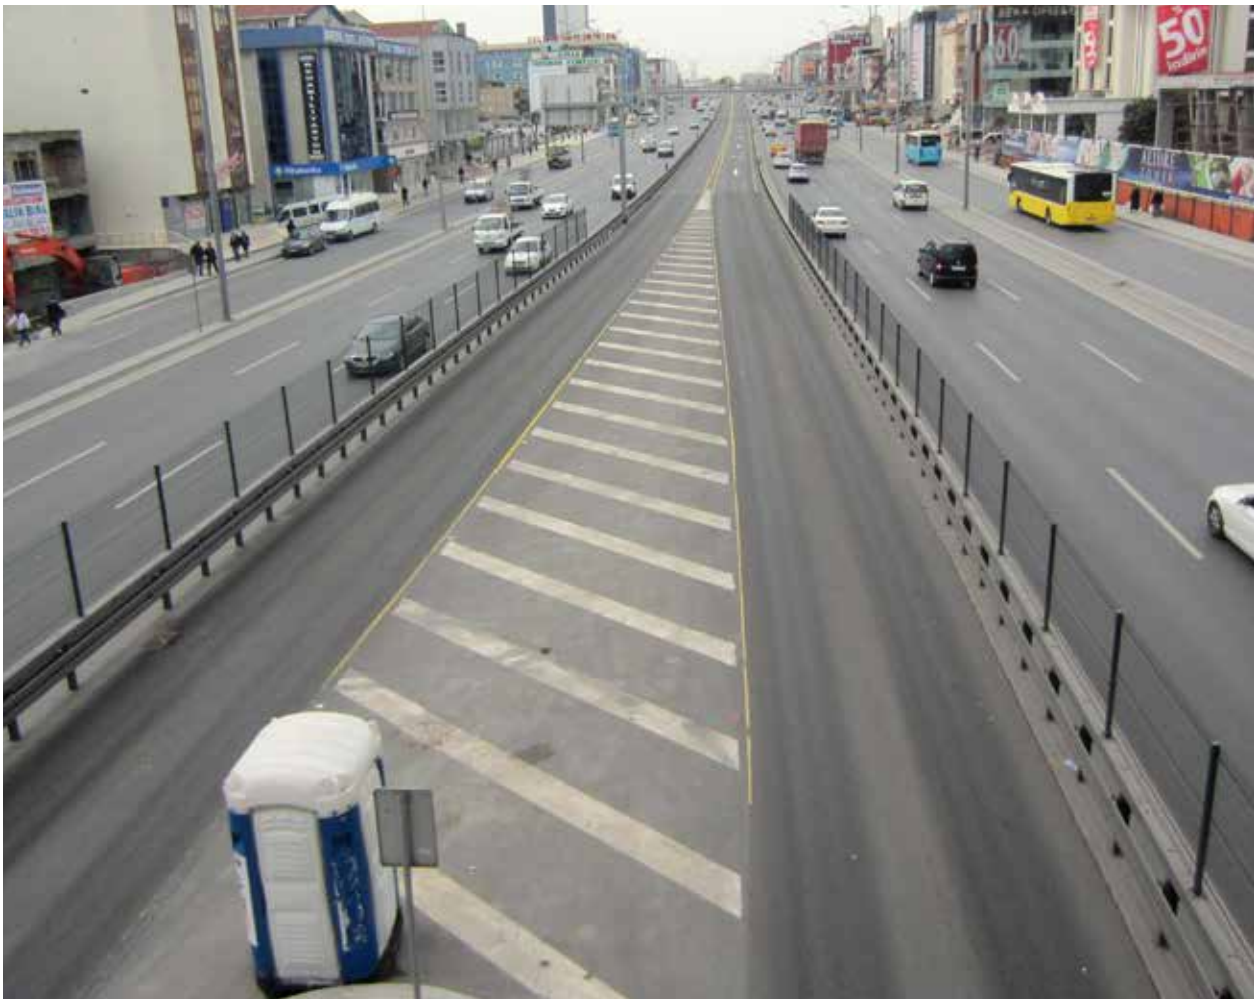
**Figure 26** Example of a station where wire fencing stretches to the end of the ghost islands

Another problem is that the ends of Metrobüs stations are open, not blocked with physical barriers. That is why passengers access the

stations over the ghost islands. To prevent this, the officials have put billboards and concrete planters to the side ends of some stations. We have observed during the inspection that 10

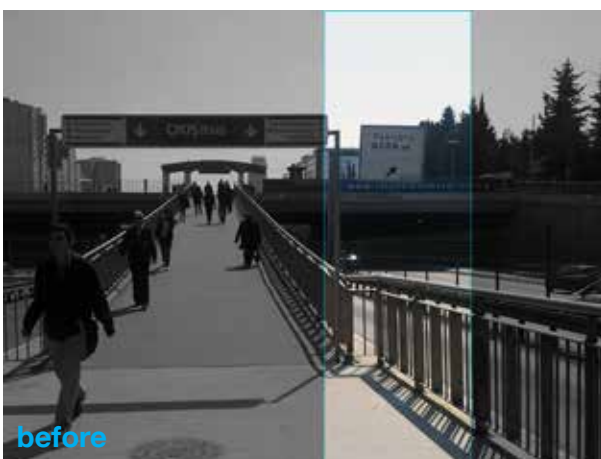
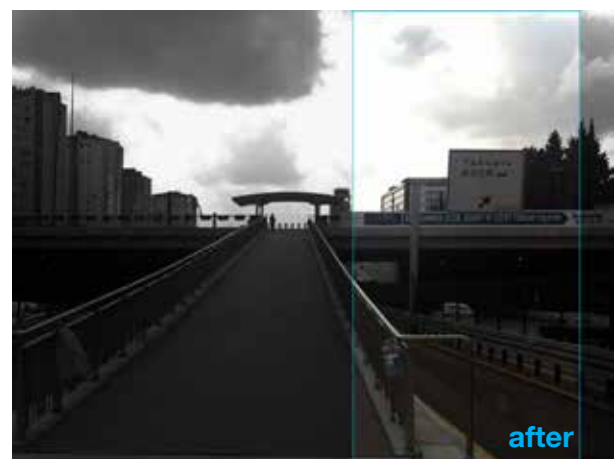
**Figure 27** Example of a station where guardrails are placed at the point of interface between over/under-passages and the station platforms to keep people away from the Metrobüs lanes

of the Metrobüs stations have been improved in that respect. 2013 inspection report also recommended closing the area where over/underpasses are interfaced with the station

platform. The majority of them were closed using guardrails. In almost all stations along the Metrobüs corridor, guardrails have been placed at the entrance points and after the stairs.

In one station only, the guardrail is in the Metrobüs lane, which poses a risk to passengers. Therefore, the passenger platform of this station should be expanded adequately to accommodate the guardrail rather than keeping it in the Metrobüs lane.

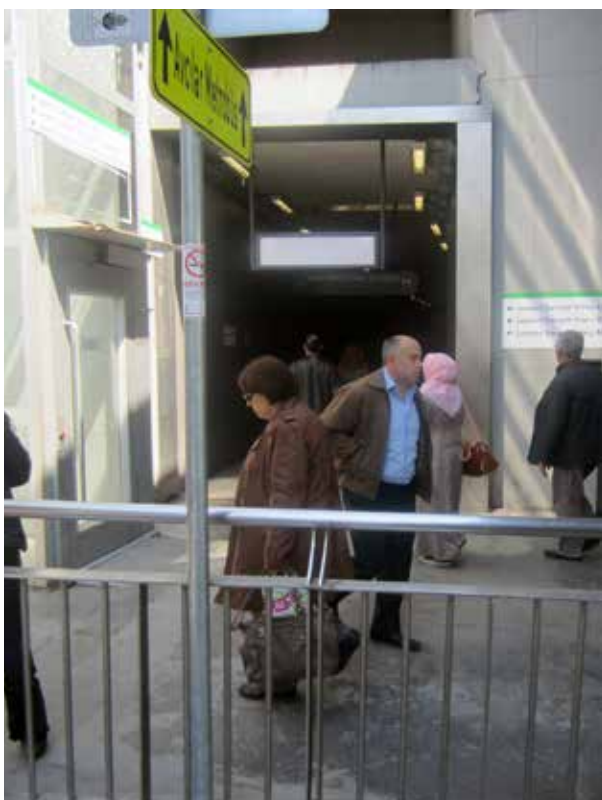
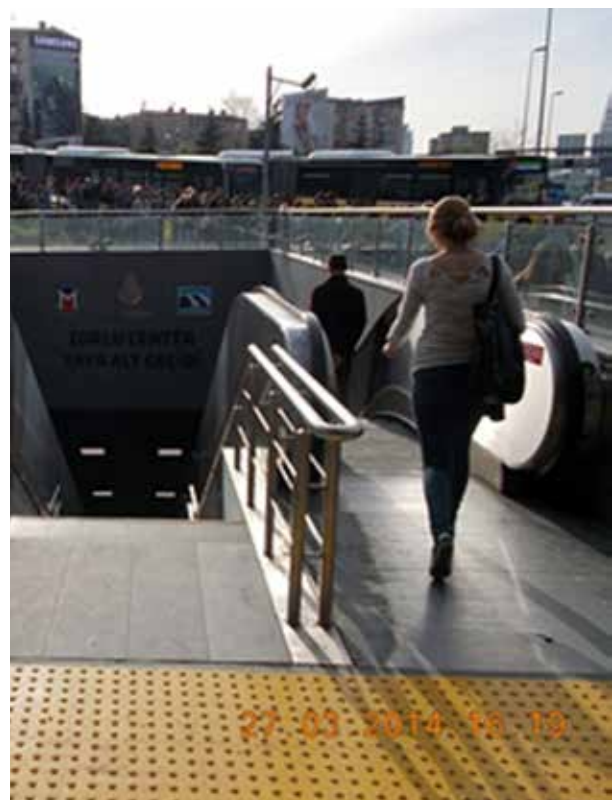
**Figure 29** Example of the recently introduced facilities in Zincirlikuyu for safe inter-modal exchange and access.

“Road Safety Inspection of Metrobüs BRT” report recommends the improvement of regular bus and minibus connection that is in close proximity to Metrobüs stations. Improvement of the connection

with the feeder bus can be done at three stages: Firstly the station platforms should be designed for easy and direct access of the passengers. Moreover, designing the exits of BRT stations close to feeder bus stations also matters a lot to facilitate passenger access and prevent them from jumping over the highway guardrails in locations where no wire fence is available. Either a large-scale approach was adopted (e.g. Mecidiyeköy and Zincirlikuyu stations) or an alternative

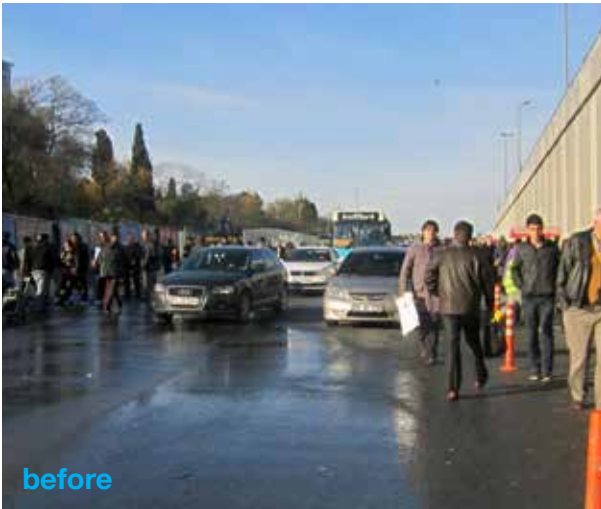
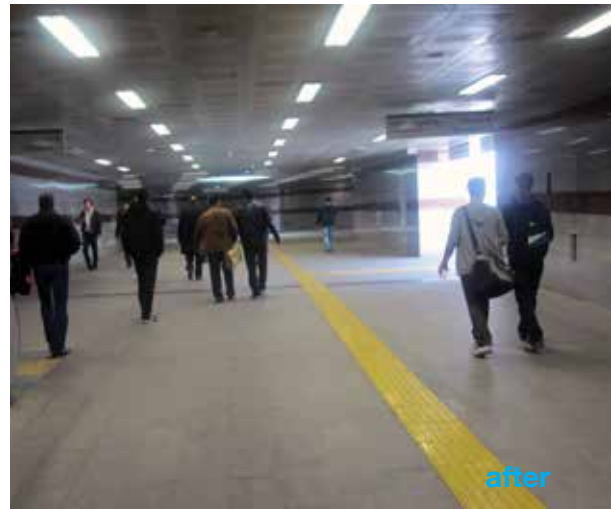
**Figure 30** Example of a safe inter-modal exchange and access in Mecidiyeköy

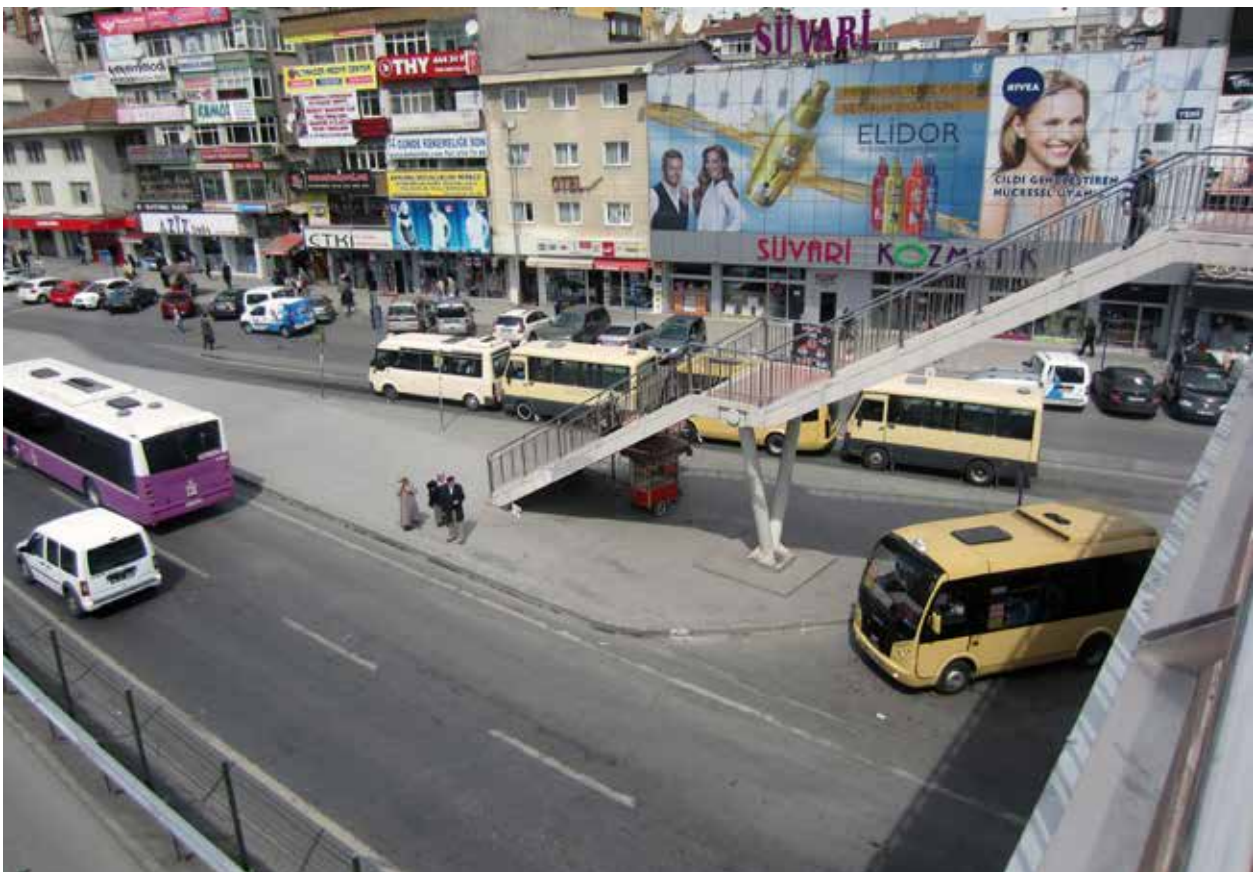
**Figure 31** Example of a new pedestrian overpass in Şirinevler

overpass was constructed (e.g. Şirinevler and Perpa stations) in majority of the stations, which have been re-designed recently.

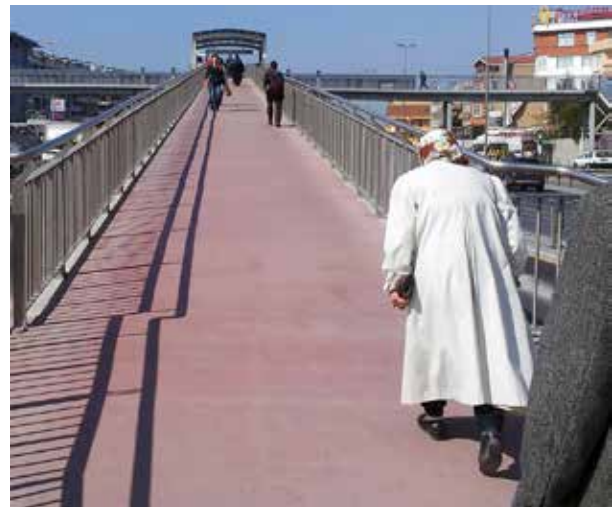
**Figure 33** Example of a station where accessibility is improved with ramps for disabled people, elderly people and people with pushchair

Ramps and elevators are available now in Zincirlikuyu, Mecidiyeköy, Çağlayan, Okmeydanı, Edirnekapı, Cevizlibağ, Beşyol, Florya, Şükrübey and Avcılar stations. Moreover, all the stations of Avcılar-Beylikdüzü line (Phase IV) have been designed for disabled access. IETT intends to adopt a holistic approach in designing the stations. Similarly, repair works are on-going in stations where elevators are broken down.

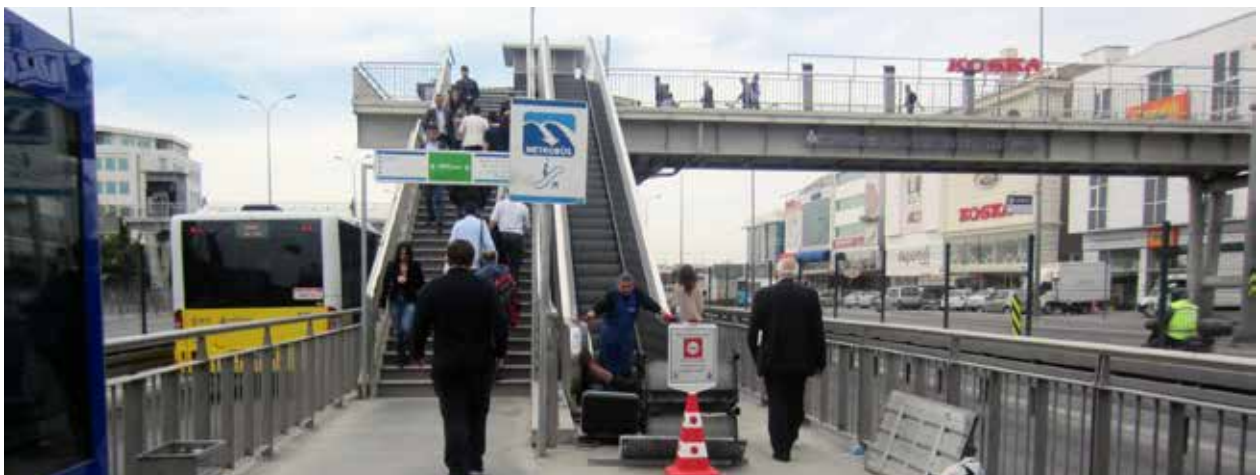
**Figure 34** Example of Infrastructure Repair and Maintenance to Improve Access to Stations

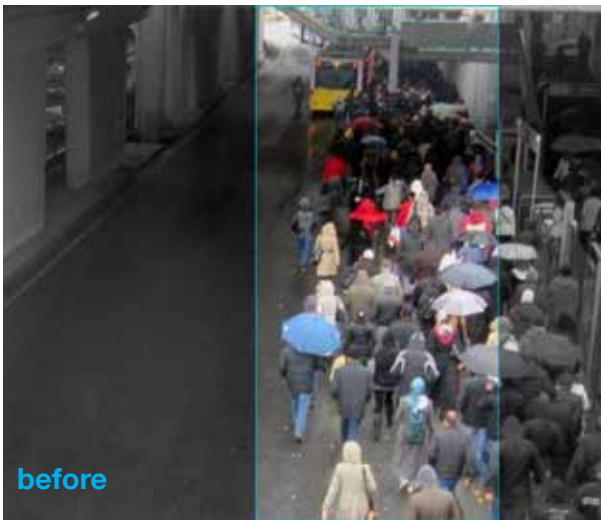
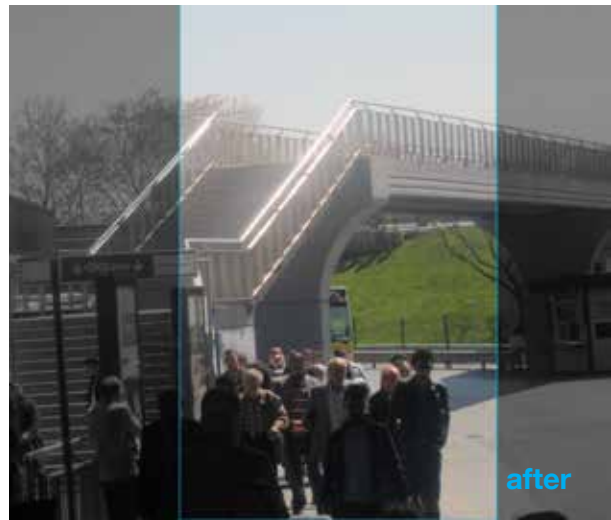
**Figure 35** The buffet in Zincirlikuyu station was removed to give more space to passengers

constructing the stations of Avcılar-Beylikdüzü line (Phase IV) platforms were designed wide enough while Mecidiyeköy and Avcılar station platforms were enlarged. Similarly, the passenger platform at Uzunçayır station was widened. Moreover, the buffet in Zincirlikuyu station was removed to give more space to passengers.

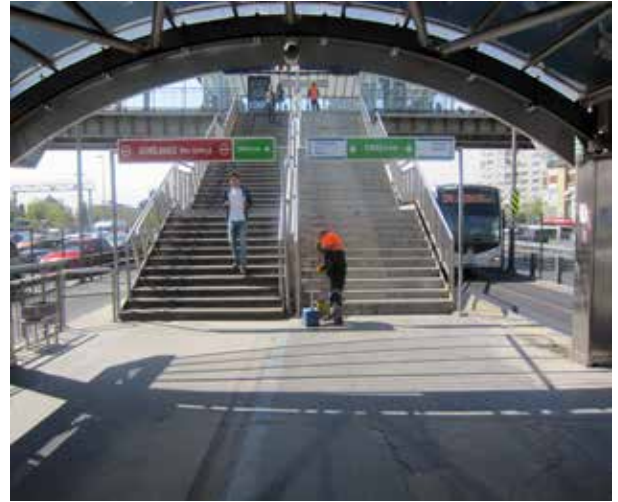
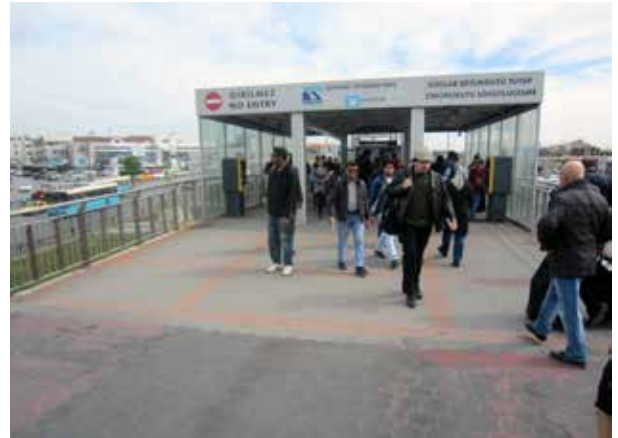
**Figure 37** Example of a station where entry and exit gates are separated

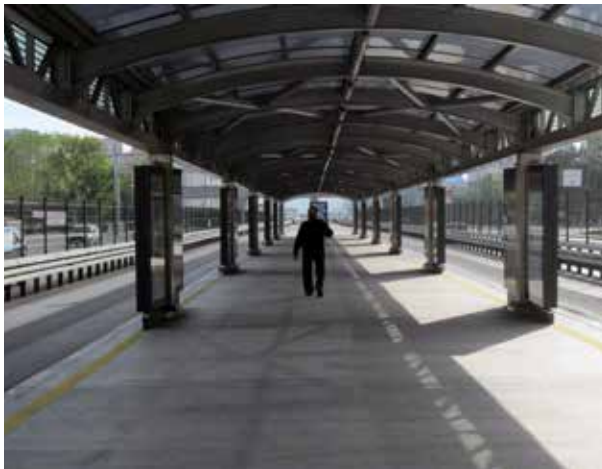
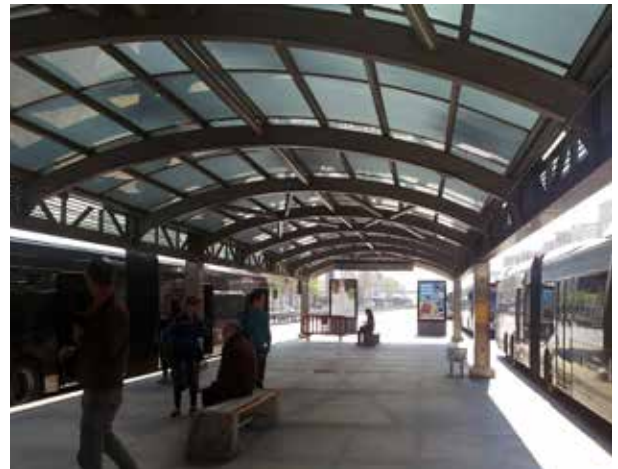
**Figure 38** Example of a station where billboards were removed from the platform ends

Billboards were relocated to the middle of the passenger platform in all the stations of Metrobüs corridor. This improvement, which is in line with the proposals given in the road safety inspection report, facilitates the boarding and alighting of the passengers. In addition to that, benches were also placed on the passenger platforms.

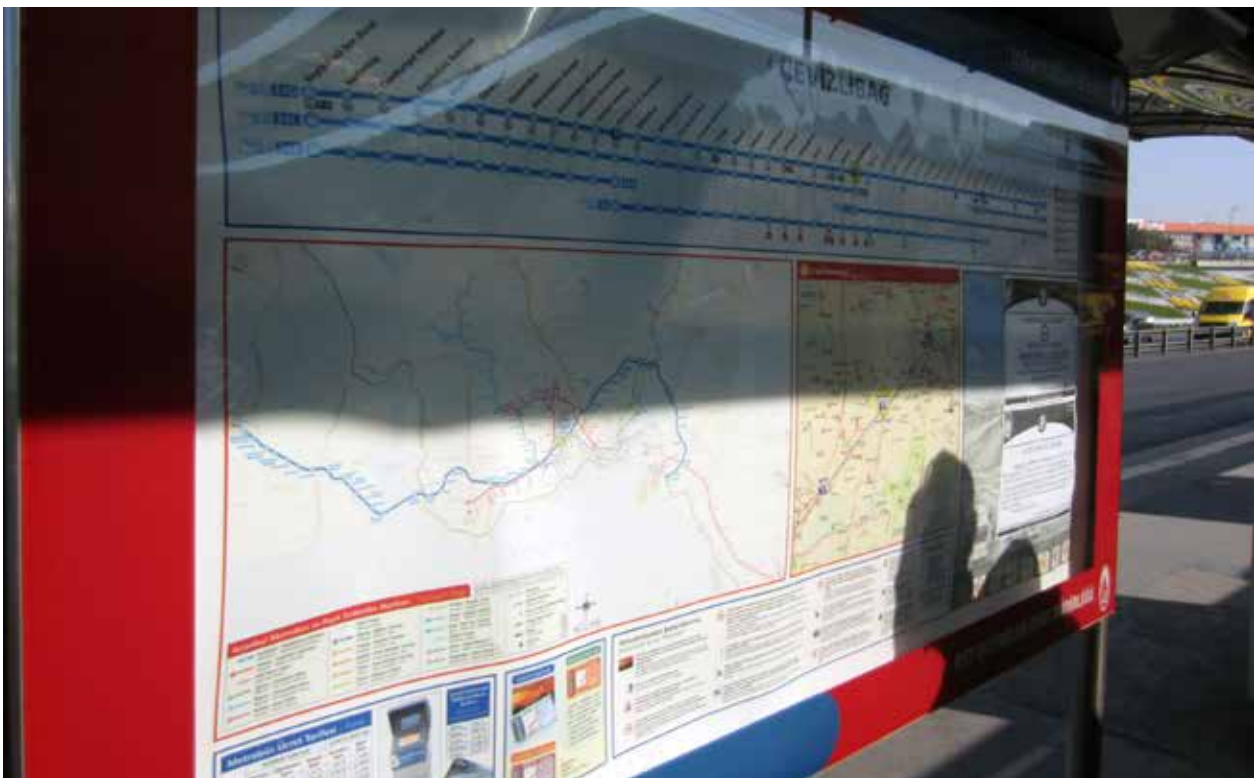
**Figure 39** Example of an information panel at a station

From the education perspective, İETT provides trainings for Metrobüs drivers. Metrobüs officials have reported that they increased the number of staff, all of whom were trained on emergency response, actions and structural problems. They also created a responsibility structure that resembles a chain of command. However, it has been observed that drivers still violate some basic safety rules. These include the violation of speed limits and not pulling alongside the passenger platform. It is essential to inform drivers about road safety and encourage them to obey the road safety rules as soon as possible. Road safety should be communicated to the passengers as well through ads, applications and information panels. An incentive programme for drivers could also be considered.
